# Trap&Treat BOS200® Case Studies

*Prepared by:  
Gabriele Giorgio Ceriani  
In-Situ Services Team Leader  
Ejlskov A/S*

# Source and plume treatment – Copenhagen (Active Gas Station) – Case Study – Performance Based Contract

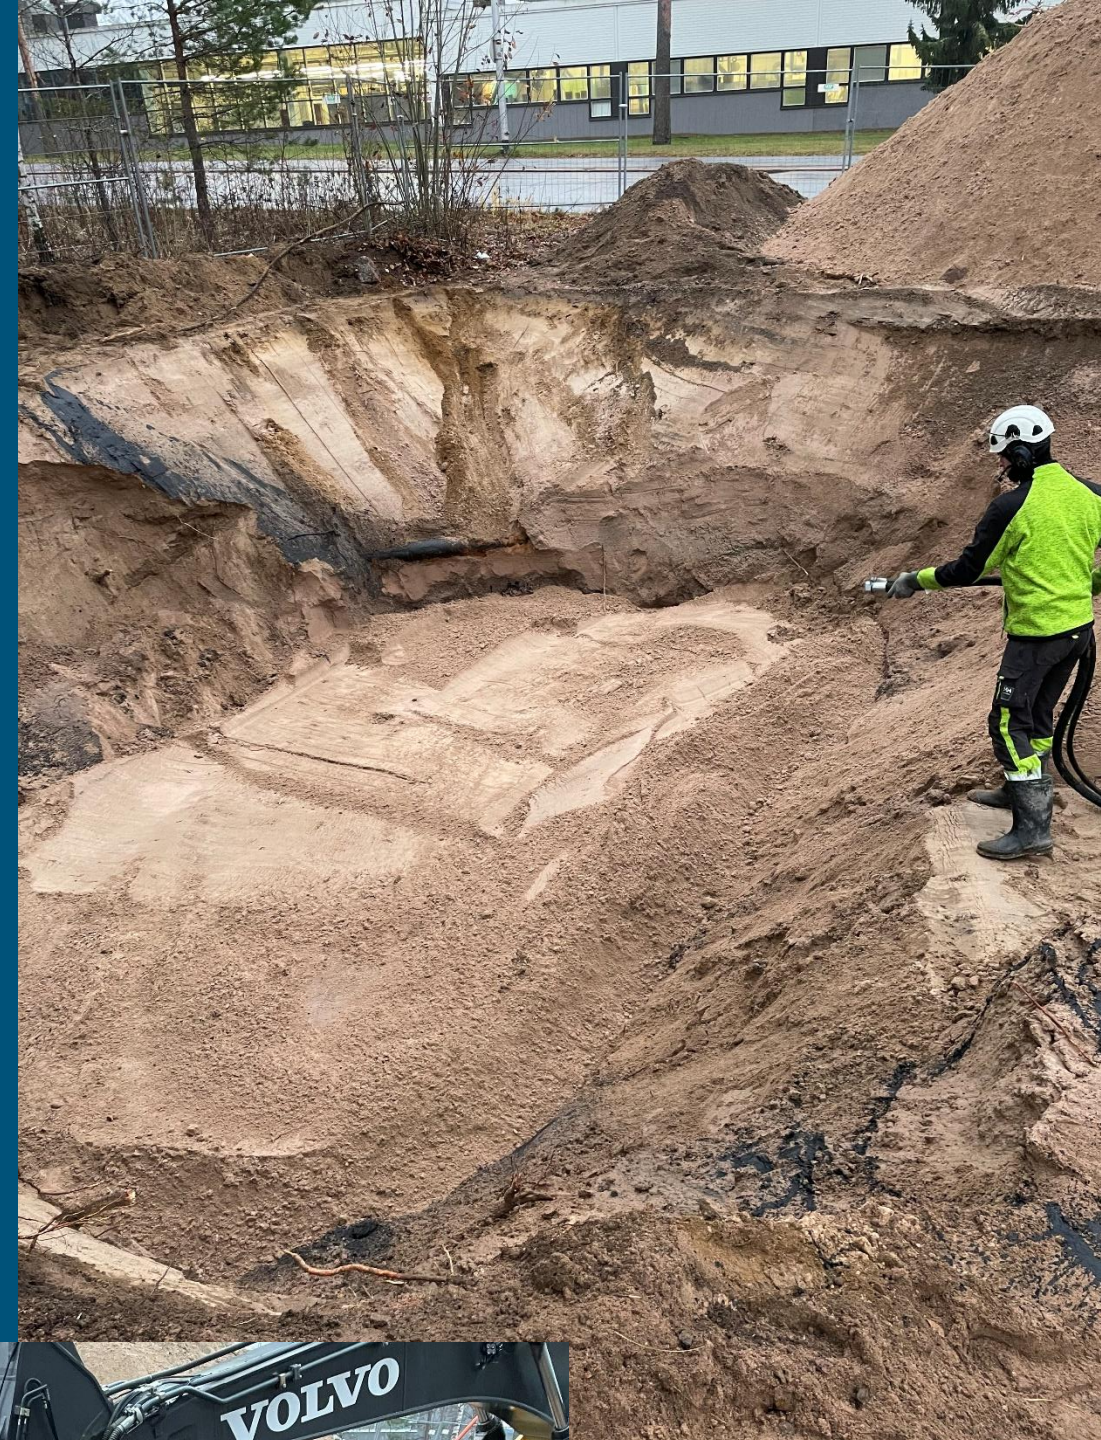
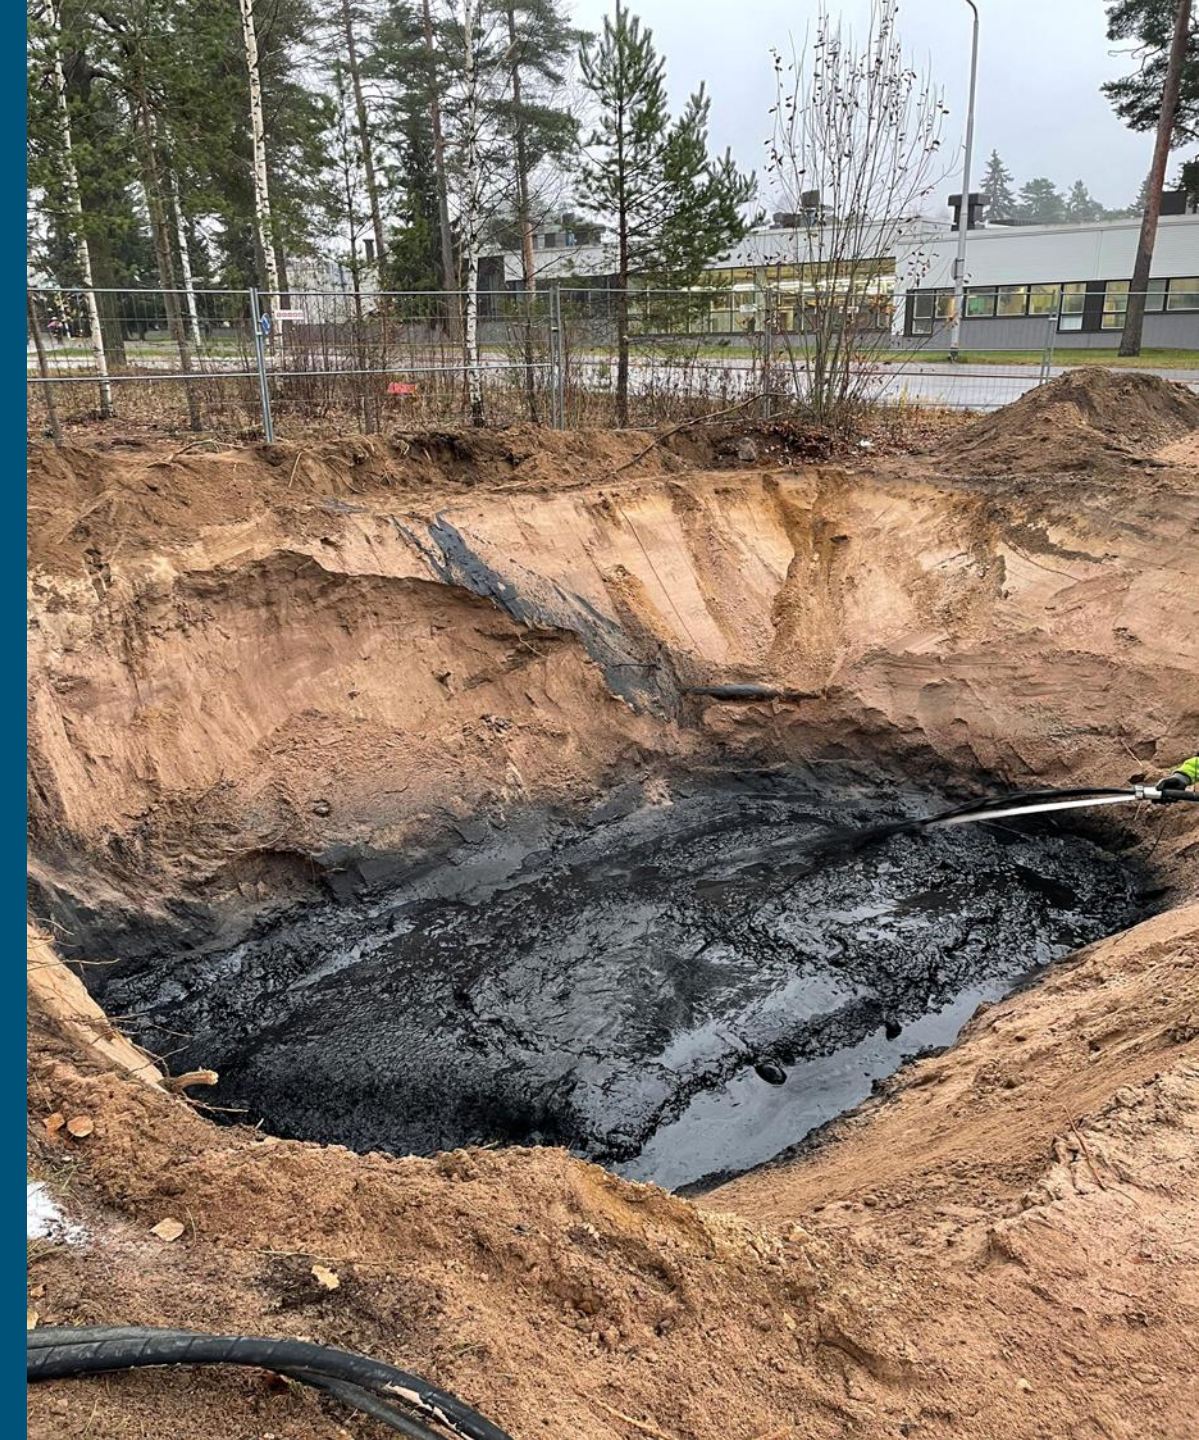
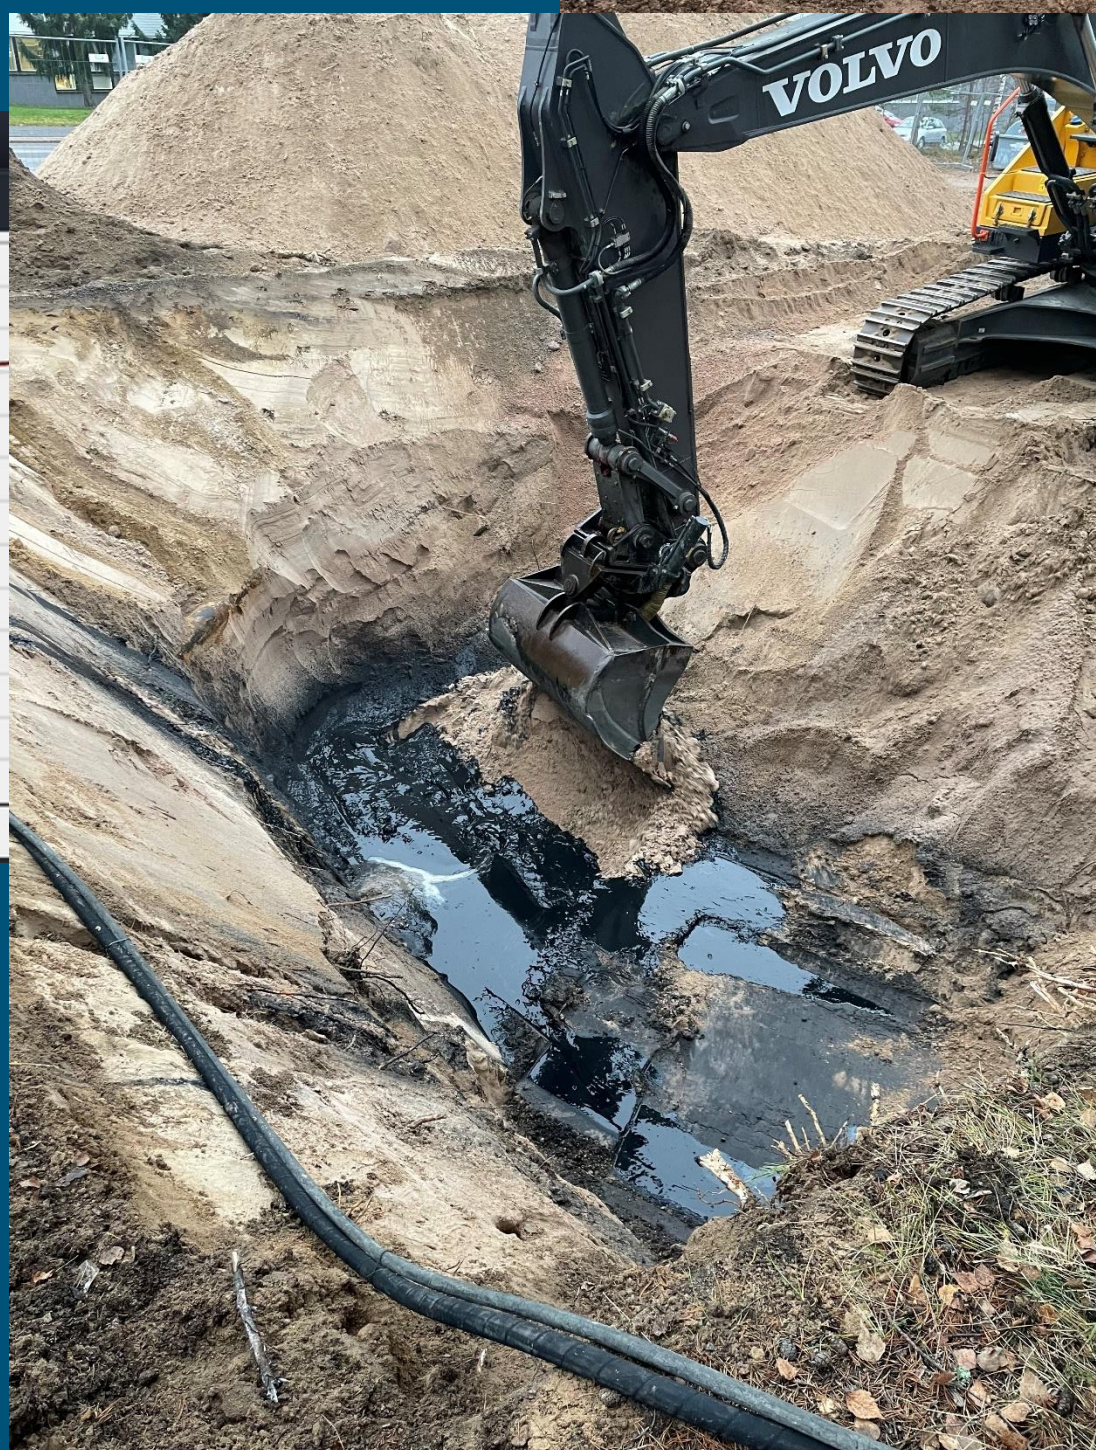
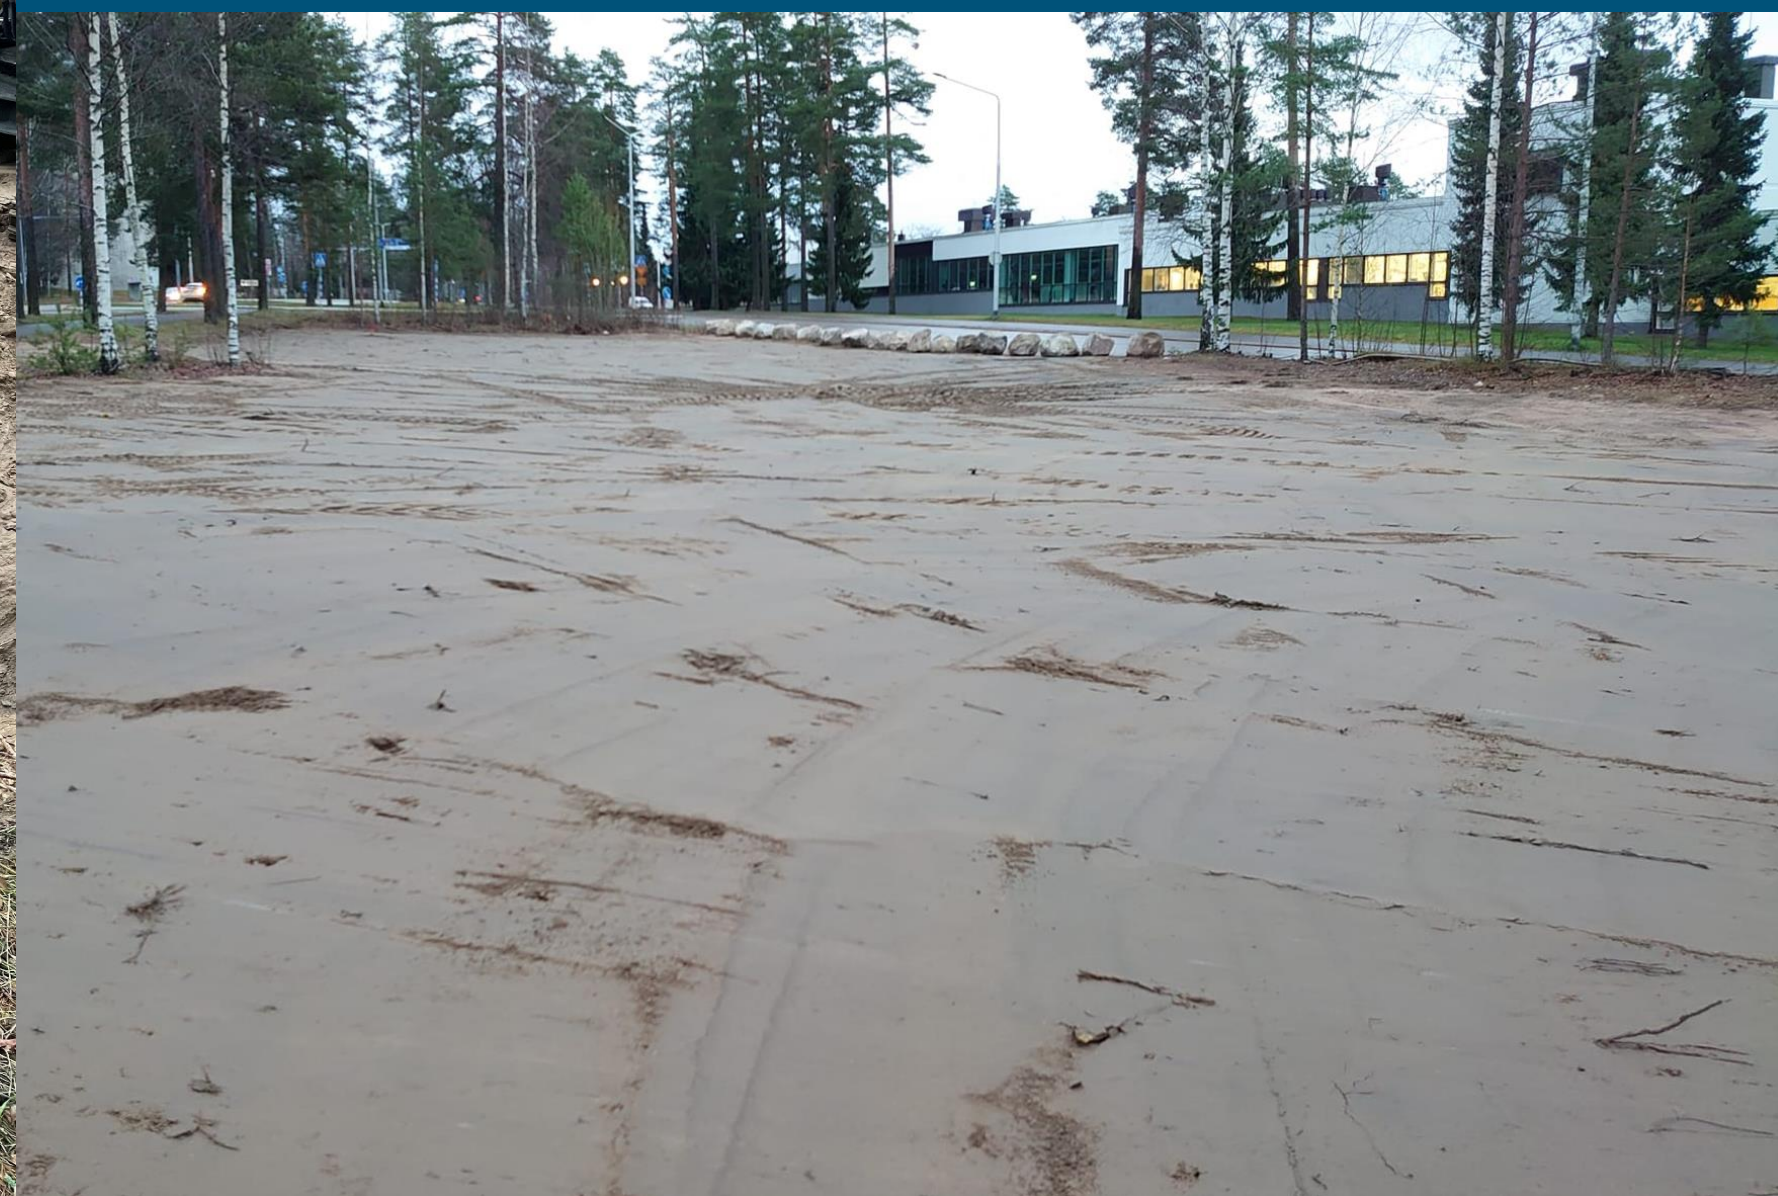
# Remediation Solution – Soil mixing / blending

- Excavation pits can be open in small areas (e.g. 5 x 5 m) and slowly advanced to depth with a bucket excavator
- Soil from the clean top layers can be temporarily stock-piled on site
- When contaminated layers are reached, BOS100® / CAT100 / BOS200® slurry and additional terminal electron acceptors or donors can be added to the formation and soil mixed by use of bucket excavator or power mixers
- The contaminated soil can always be mixed inside the excavation pit
- Clean top-soil is compacted at completion of soil mixing operations

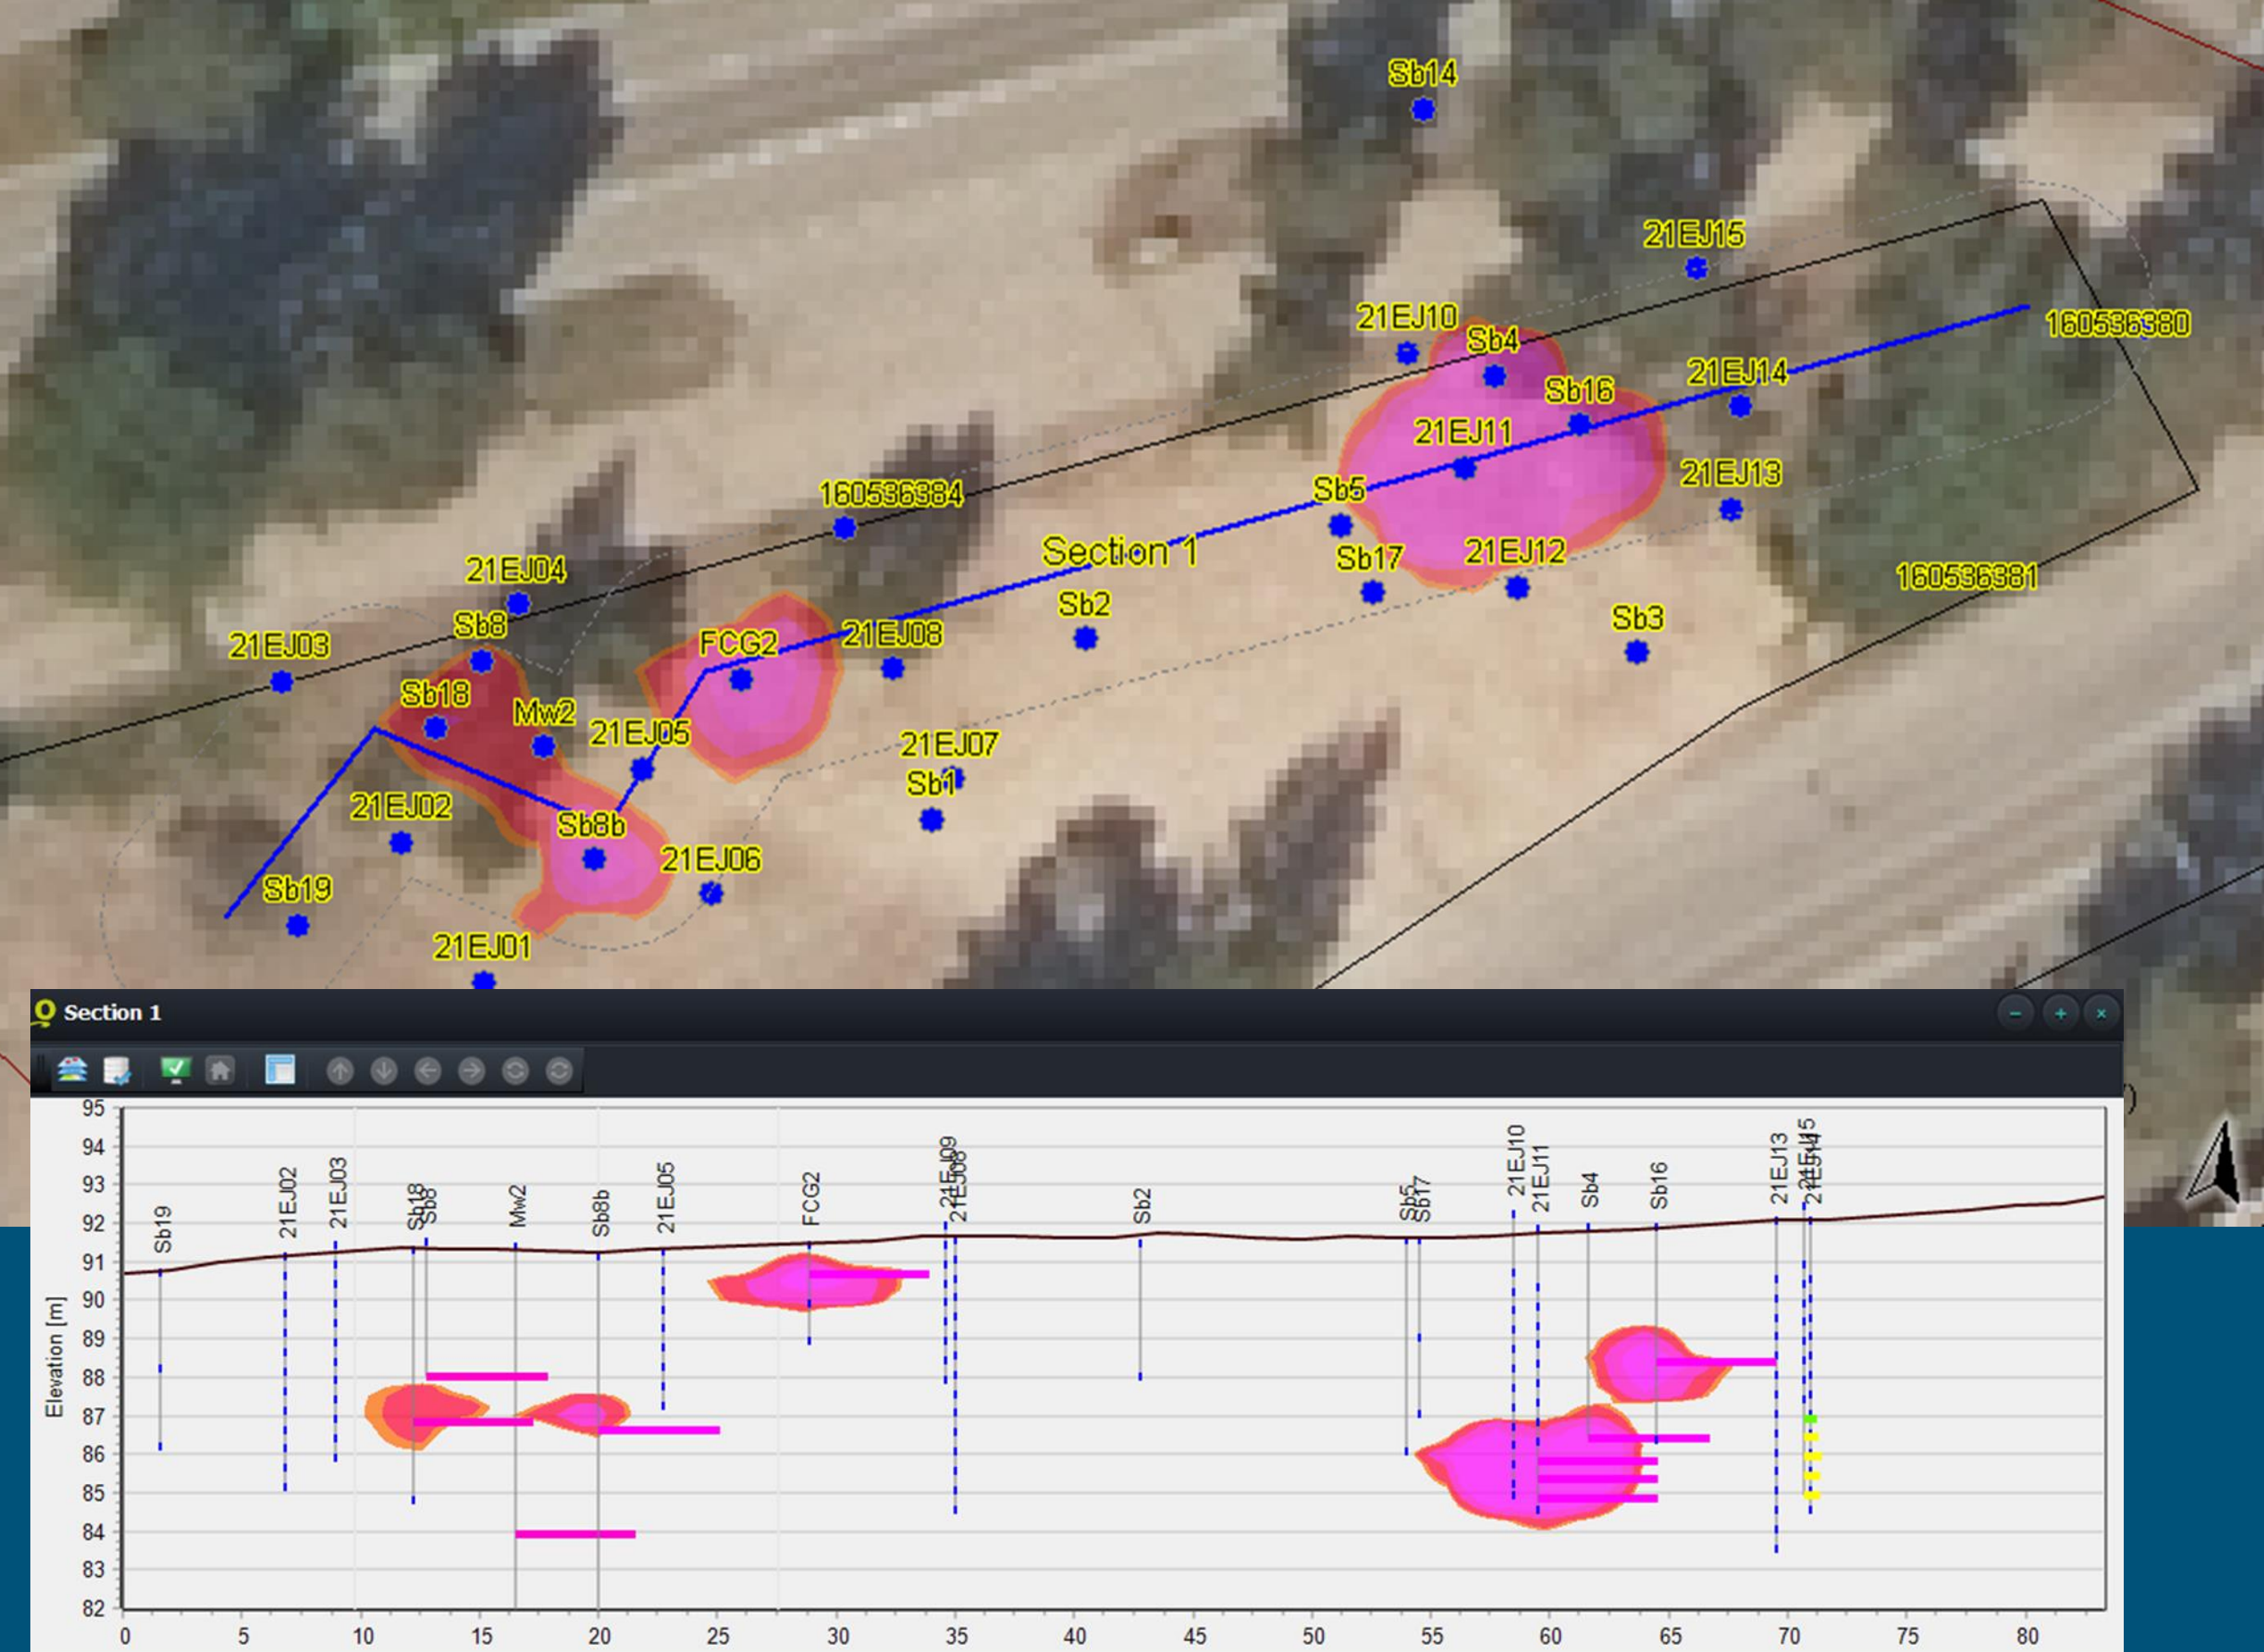
# Case Study – TPH Soil Contamination – Soil Mixing

On the left – Soil contamination prior to BOS200® treatment  
Below – Soil condition after soil validation 24 months post treatment (colored areas showing treatment zones)  
95% TPH mass reduction measured by collection of high-density soil data compared to pre-remediation soil data

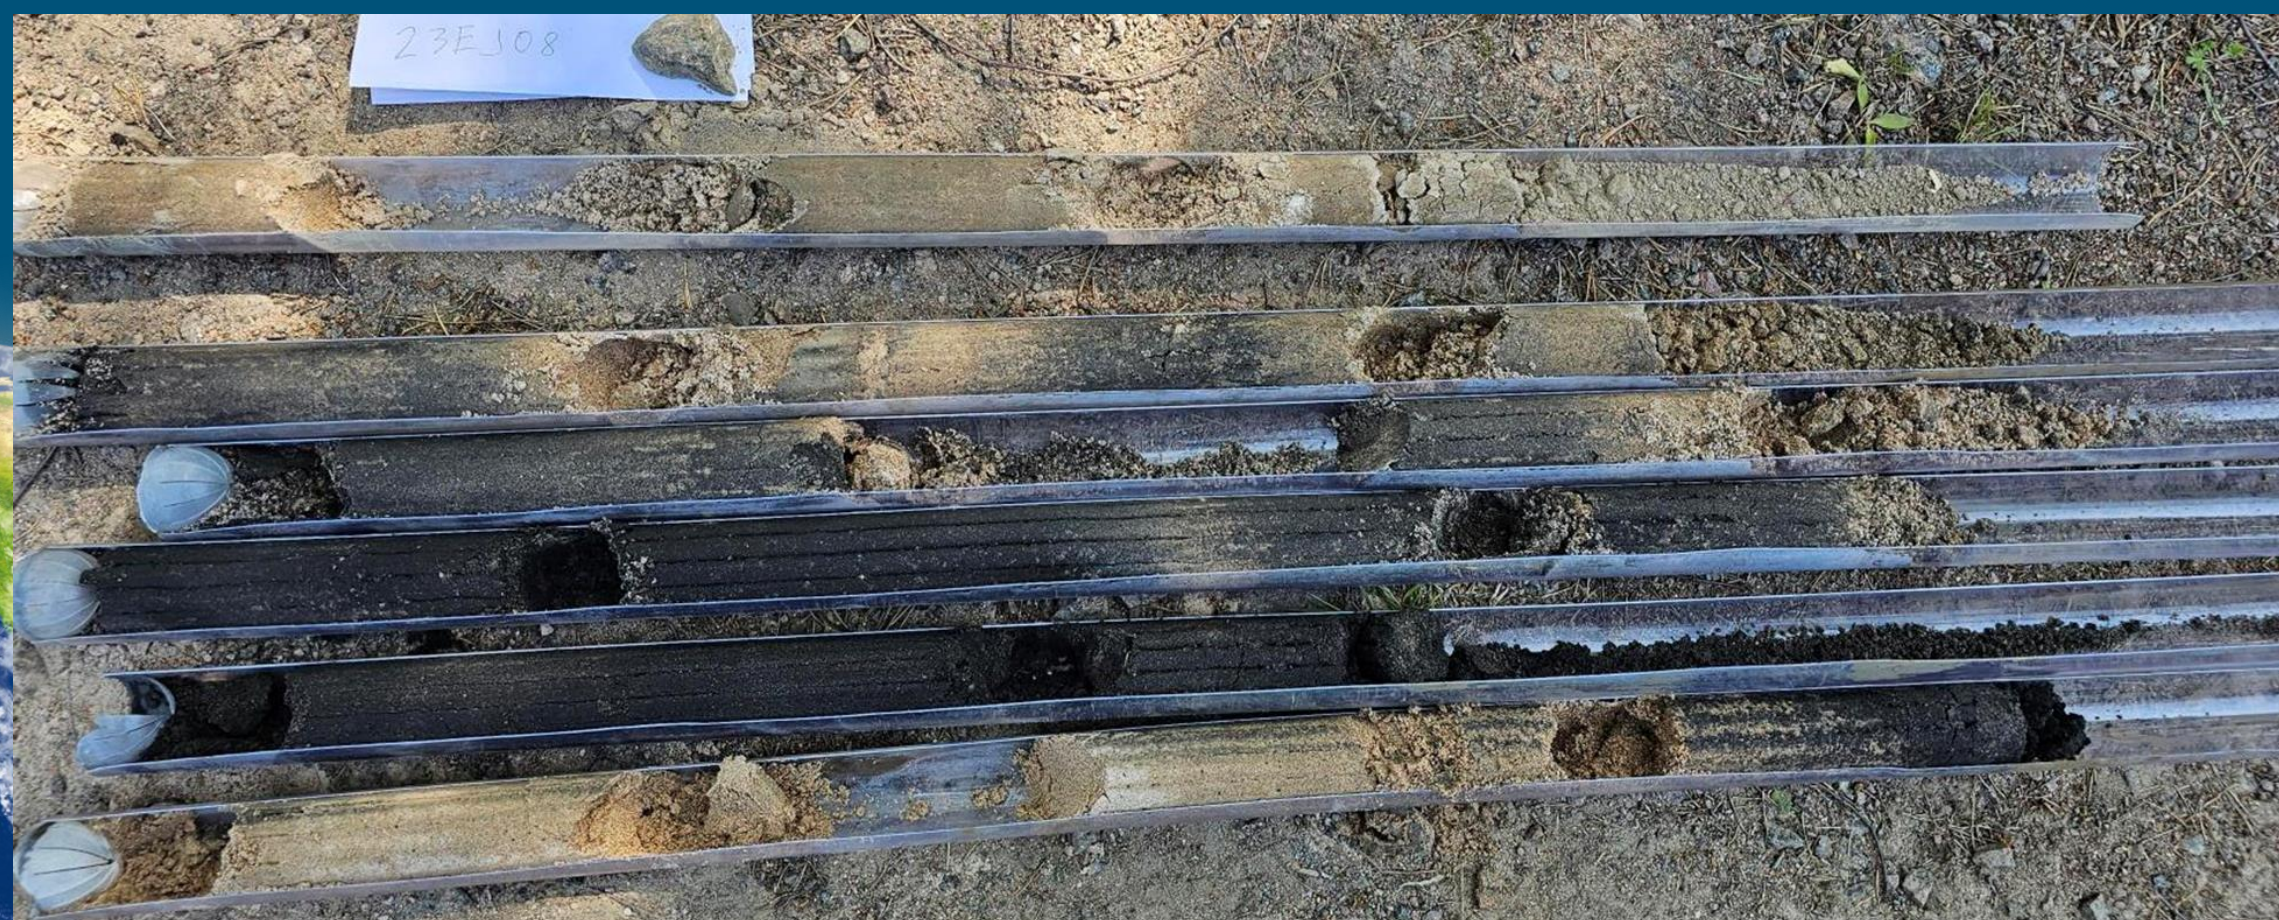
In all executed soil cores, it was possible to confirm presence of BOS200® slurry mixed with the soil within the treatment depths. One example provided to the left
